# PAS 24:2022

**Product Tested:** Alunet horizontal sliding patios fitted with 50mm interlock trim

**Test N°:** T2394

**Report N°:** MTCR0199

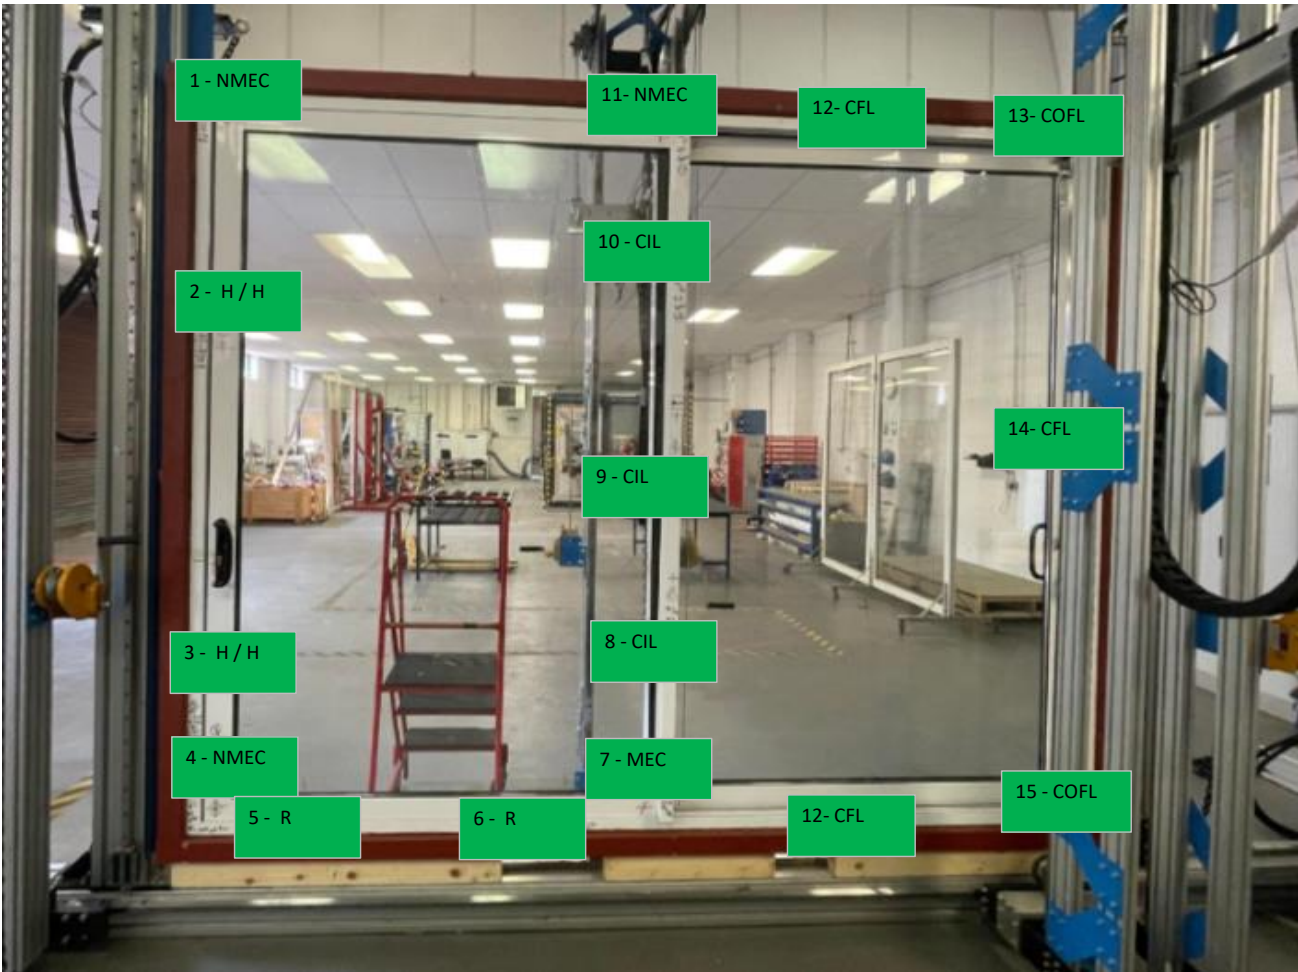
Figure 1. Photograph of test sample which indicates loading points and sequence

| NMEC - Non Meeting Edge Corner | CFL = Centre Fixed Light |
| H / H = Hook Bolt / Hook Bolt | COFL = Corner Fixed Light |
| R = Roller | |
| MEC - Meeting Edge Corner | |
| CIL = Continuous Interlock | |

Table 5. Clause B.4.5 Mechanical Loading results - *Direction of loads applied are as viewed from outside face.*

Test ref point	Parallel-to-plane		Equal & opposite		Perpendicular loads		Loading case used	Component failure	Result
	Direction	Load applied	Direction	Load applied	Perpendicular	Opposite			
1	⇒	4.5kN					1		Pass

1.1	⇓	1.5kN			4.5Kn		1		Pass
2	⇑	1.5kN			4.5Kn		7		Pass
2.1	⇓	1.5kN			4.5Kn		7		Pass
2.2	⇒	1.5kN			4.5Kn		7		Pass
2.3	⇒	4.5kN					7		Pass
3	⇑	1.5kN			4.5Kn		7		Pass

3.1	⇓	1.5kN			4.5Kn		7		Pass
3.2	⇒	1.5kN			4.5Kn		7		Pass
3.3	⇒	4.5kN			4.5Kn		7		Pass
4	⇒	4.5kN					1		Pass
4.1	⇑	1.5kN			4.5Kn		1		Pass
5	⇑	4.5kN			1.5kN		10		Pass
6	⇑	4.5kN			1.5kN		10		Pass
7					4.5Kn	4.5Kn	5		Pass
8					4.5Kn	4.5Kn	5		Pass
9					4.5Kn	4.5Kn	5		Pass
10					4.5Kn	4.5Kn	5		Pass
11					4.5Kn	4.5Kn	5		Pass
12	⇓	1.5kN			4.5Kn		11		Pass
13	⇐	1.5kN			4.5Kn		12		Pass

13.1	⇓	1.5kN			4.5Kn		12		Pass
14	⇐	1.5kN			4.5Kn		11		Pass
15	⇐	1.5kN			4.5Kn		12		Pass
15.1	⇑	1.5kN			4.5Kn		12		Pass
16	⇑	1.5kN			4.5Kn		11		Pass

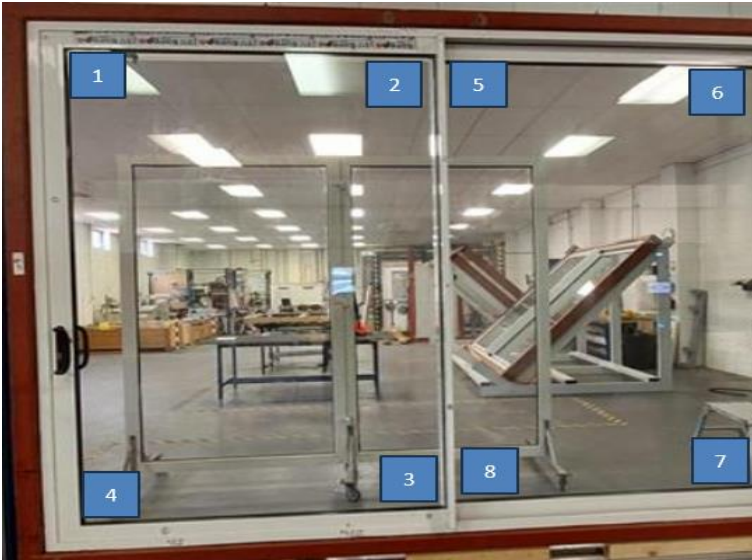
The sample was installed into the test rig square and true in accordance with B.3.1 and was tested in accordance with clause B.4.4.3 with loads of 2.0kN applied progressively, without shock to every corner of the glazing retention system. The objective of this test is to establish the strength and resistance to forces applied to the glazing with the view to pushing the glass out from the exterior face of the sample to gain entry.

Test Ref Point	Load Applied	Result
1	2kN	Pass
2	2kN	Pass
3	2kN	Pass
4	2kN	Pass
5	2kN	Pass
6	2kN	Pass
7	2kN	Pass
8	2kN	Pass

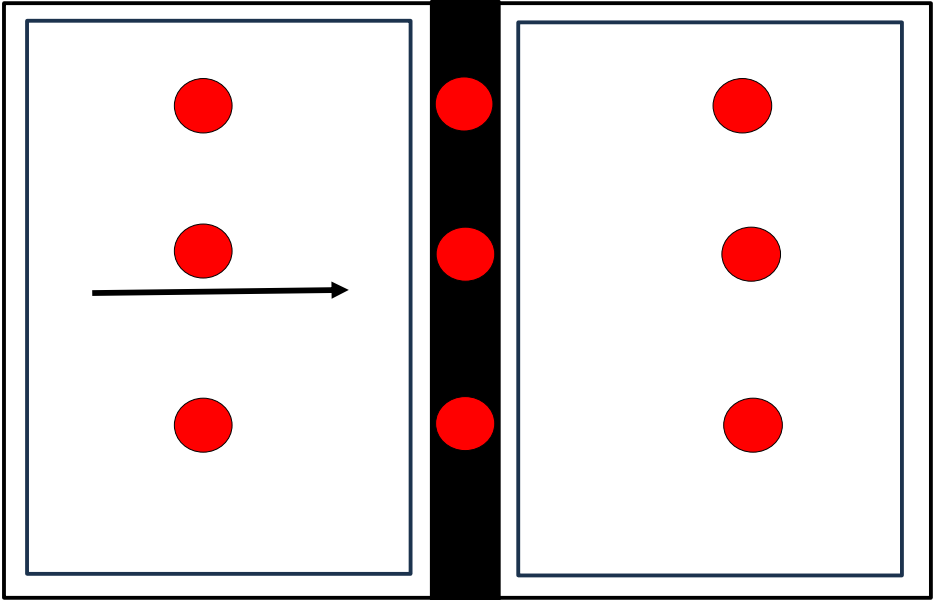
*Viewed from outside*

The sample was installed into the test rig square and true in accordance with B.3.1 and was tested in accordance with clause B.4.8 with all impact positions defined by the style of sample submitted. The objective of this test is to assess the doorset's resistance to impacts using a soft body by striking each impact point 3 times from the exterior face of the door leaf at 0.8m, and 1.7m above floor level.

= Impact locations
- 1    =    0.8M
  - 2    =    1.25M
  - 3    =    1.7M
  - 4    =    0.8M
  - 5    =    1.25M
  - 6    =    1.7M
  - 7    =    0.8M
  - 8    =    1.25M
  - 9    =    1.7M

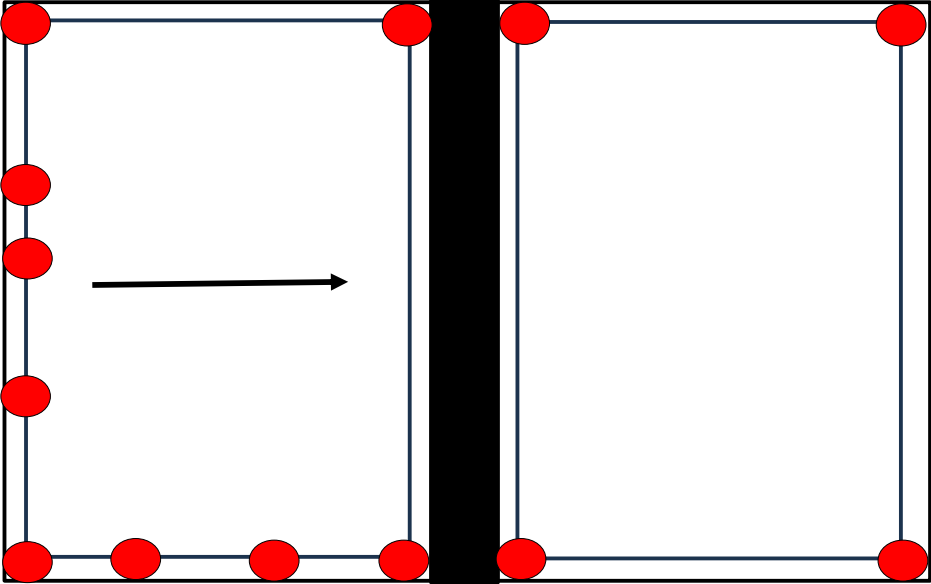
*Viewed from outside - Impact sequence starts from top corner on the hinge side.*

The sample was installed into the test rig square and true in accordance with B.3.1 and was tested in accordance with clause B.4.9.2.2 with all impact positions defined within this clause. The objective of this test is to assess the doorset's resistance to impacts using a hard body by striking each impact point 3 times from the exterior face of the door leaf.

- 1 - top left corner
- 2 - top hooks
- 3 - cylinder
- 4 - lower hooks
- 5 - bottom left corner
- 6 - left roller
- 7 - right roller
- 8 - bottom right corner of moving leaf
- 9 - bottom left corner of fixed light
- 10 - bottom right corner of fixed light
- 11 - top right corner of fixed light
- 12 - top left corner of fixed light
- 13 - top right corner of moving leaf
