PAS 24:2022 Annex A & B

Product Tested: Alunet horizontal sliding patios fitted with 25mm trim	Date:	16/06/2023
	Version:	Original
	Issue Nº:	1
	Test Nº:	T2396
Conducted for: Alunet Systems	Report Nº:	MTCR0200

Enhanced security performance requirements for Doorsets and Windows in the UK

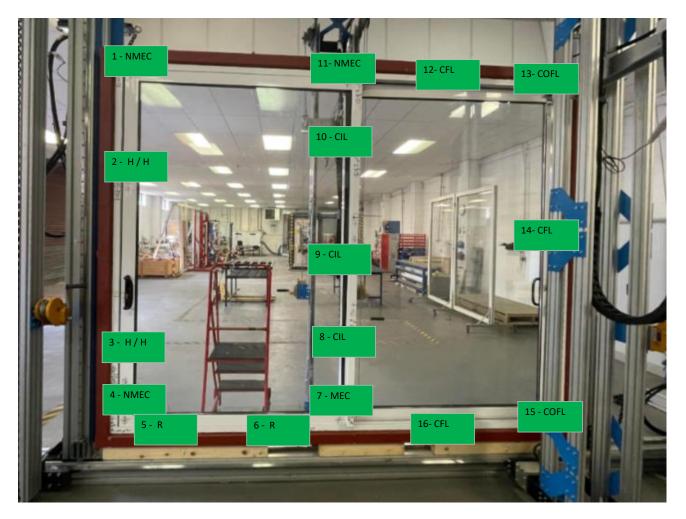
Figure 1. Photograph of test sample which indicates loading points and sequence

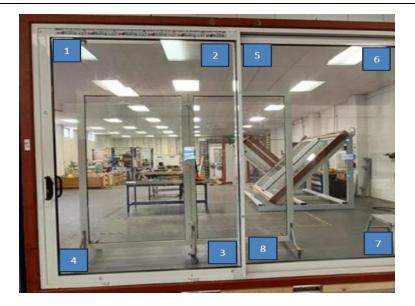
B.4.4.3 Mechanical Test on Infill The sample was installed into the test rig square and true in accordance with B.3.1 and was tested in accordance with clause B.4.4.3 with loads of 2.0kN applied progressively, without shock to every corner of the glazing retention system. The objective of this test is to establish the strength and resistance to forces applied to the glazing with the view to pushing the glass out from the exterior face of the sample to gain entry.

Test Ref Point	Load Applied	Result
1	2kN	Pass
2	2kN	Pass
3	2kN	Pass
4	2kN	Pass
5	2kN	Pass
6	2kN	Pass
7	2kN	Pass
8	2kN	Pass

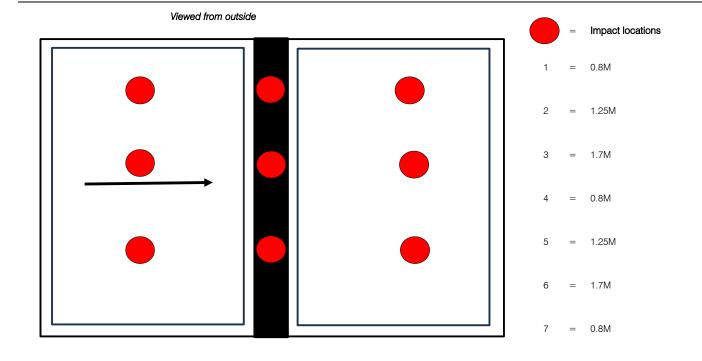
The sample was installed into the test rig square and true in accordance with B.3.1 and was tested in accordance with

clause B.4.8 with all impact positions defined by the style of sample submitted. The objective of this test is to assess the doorset's resistance to impacts using a soft body by striking each impact point 3 times from the exterior face of the door

leaf at 0.8m, and 1.7m above floor level.

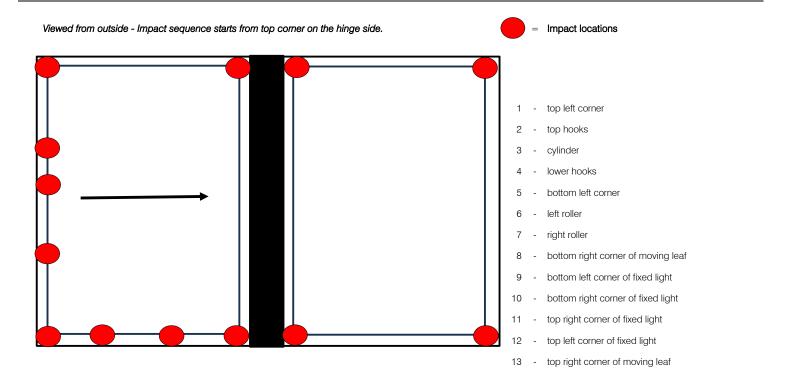
The sample was installed into the test rig square and true in accordance with B.3.1 and was tested in accordance with

clause B.4.9.2.2 with all impact positions defined within this clause. The objective of this test is to assess the doorset's resistance to impacts using a hard body by striking each impact point 3 times from the exterior face of the door leaf.
