PAS 24:2022

# Product Testing To Exceed Industry Standards

Product Tested: Alunet horizontal sliding patios fitted with 25mm trim

Conducted for: Alunet Systems Report No: MTCR0200

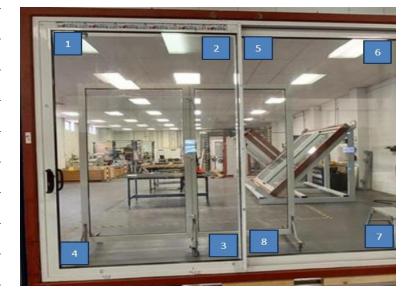
B.4.4.3 Mechanical Test on Infill The sample was installed into the test rig square and true in accordance with B.3.1 and was tested in accordance with clause B.4.4.3 with loads of 2.0kN applied progressively, without shock to every corner of the glazing retention system. The objective of this test is to establish the strength and resistance to forces applied to the glazing with the view to pushing the glass out from the exterior face of the sample to gain entry.

Test Ref Point	Load Applied	Result
1	2kN	Pass
2	2kN	Pass
3	2kN	Pass
4	2kN	Pass
5	2kN	Pass
6	2kN	Pass
7	2kN	Pass
8	2kN	Pass

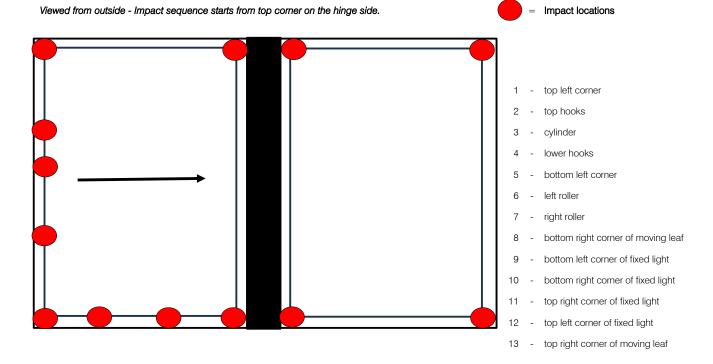
B.4.9.2.2 Hard Body Impact Test Door Leaf The sample was installed into the test rig square and true in accordance with B.3.1 and was tested in accordance with clause B.4.9.2.2 with all impact positions defined within this clause. The objective of this test is to assess the doorset's resistance to impacts using a hard body by striking each impact point 3 times from the exterior face of the door leaf.
